# Double Adobe Elementary School Limited Asbestos Report

7081 North Central Highway  
McNeal, Arizona 85617

December 12, 2016

This limited asbestos survey report contains the results of a limited AHERA-style asbestos inspection conducted for Double Adobe Elementary School (DAES). The limited asbestos inspection was conducted at DAES located at 7081 North Central Highway, McNeal, Arizona 85617. RTC was authorized by DAES, to perform the limited asbestos inspection.

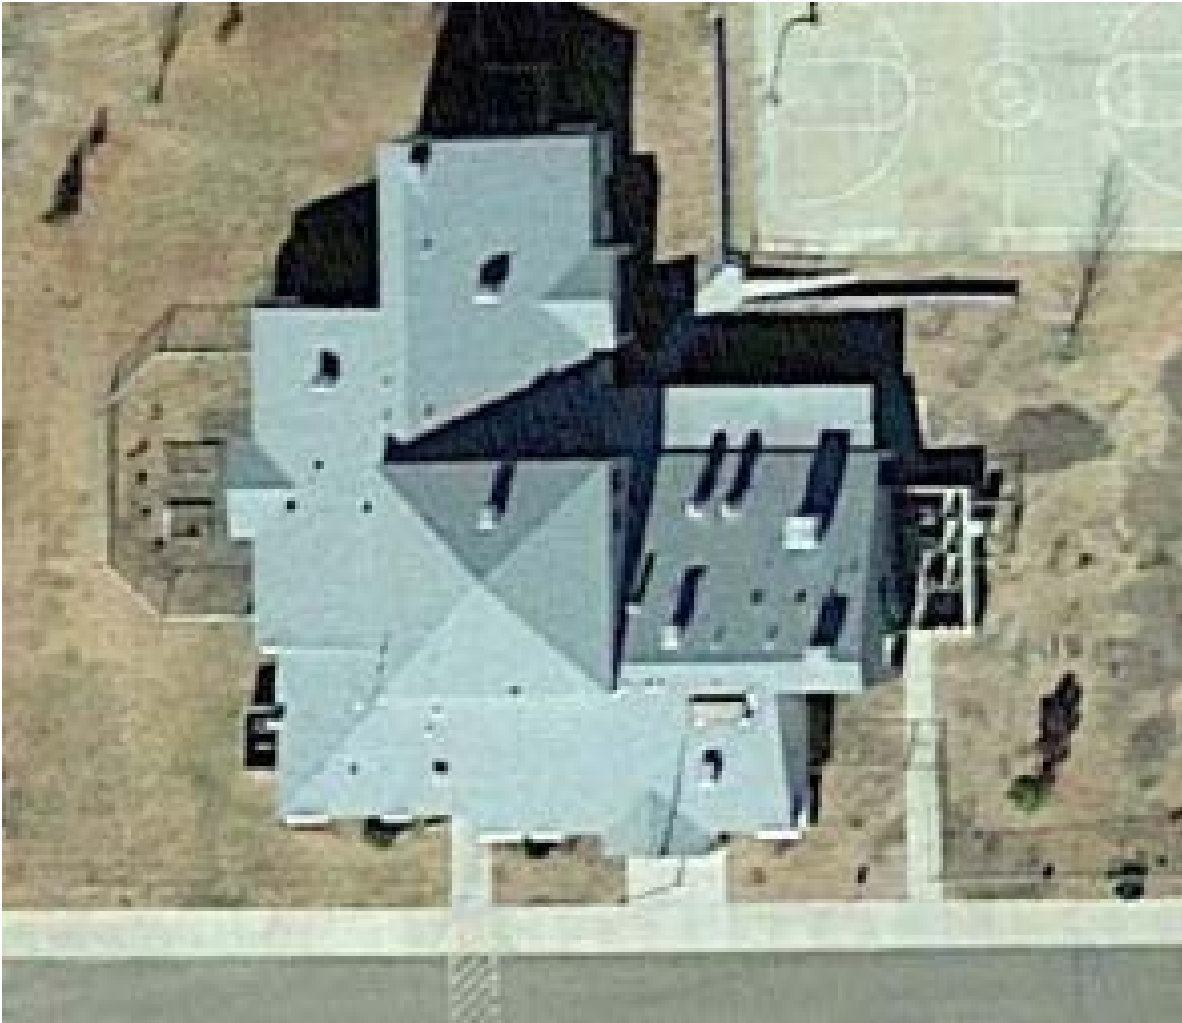
**SITE MAP**

Site Map of Double Adobe Elementary School.

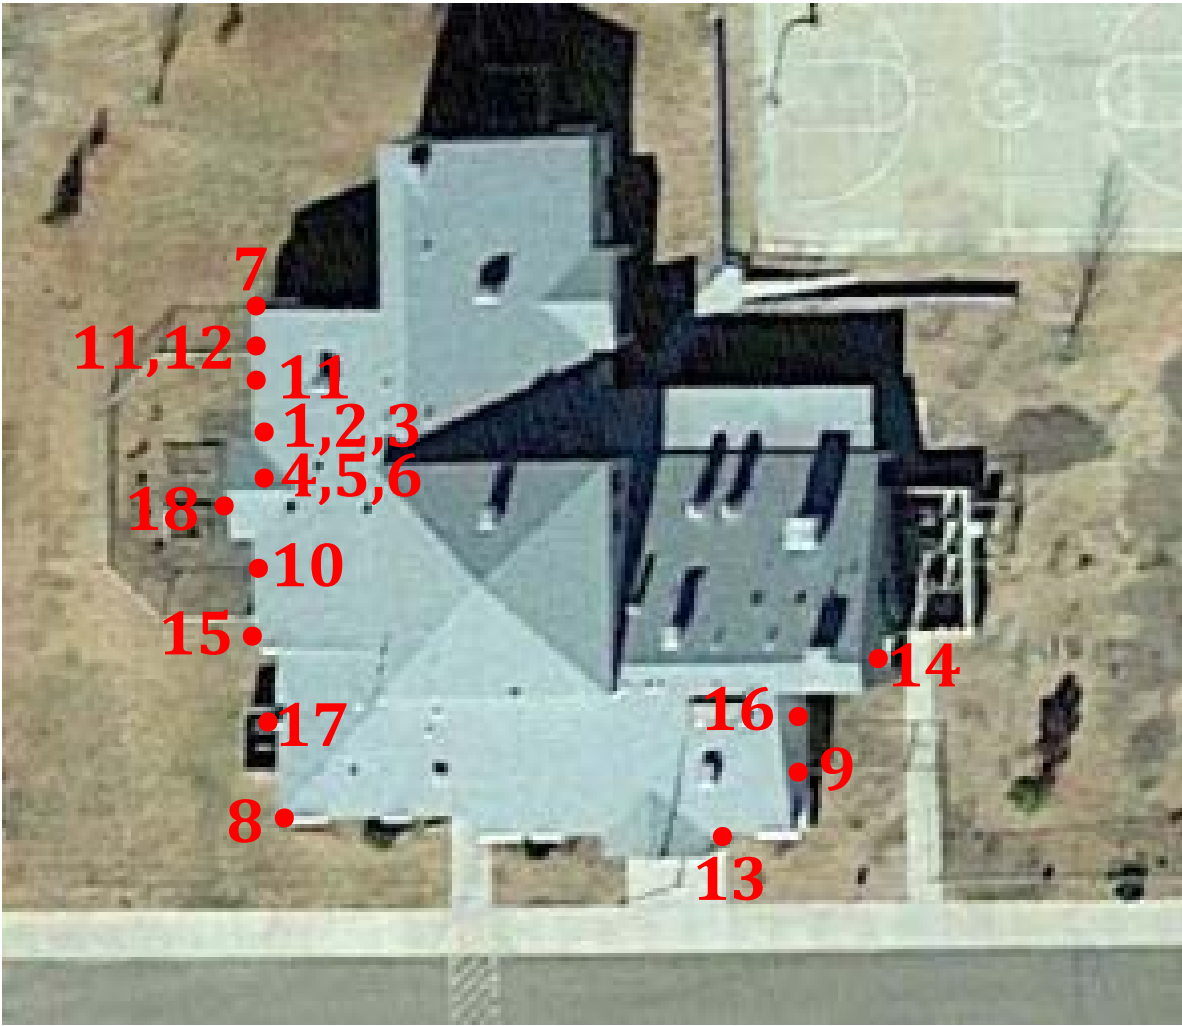
**PLM BULK SAMPLE LOCATION MAP**

A total of eighteen (18) bulk samples were collected from the suspect building materials within the outlined areas of the building. The suspect bulk samples were submitted to EMLab P&K, LLC (EMLab) for analysis using Polarized Light Microscopy (PLM) methods. EMLab used the methods prescribed in Method 40 CFR, Part 763, in the Code of Federal Register in analyzing bulk samples. EMLab is certified by the National Institute of Standards and Technology (NIST) as adhering to and in compliance with the National Voluntary Laboratory Accreditation Program (NVLAP) and holds the certification number 500031-0. The suspect asbestos bulk samples were collected and submitted to the laboratory using established chain of custody procedures. Bulk samples were collected utilizing safety and health practices as required by the Occupational Safety and Health Administration (OSHA).

- Tape/Texture/Drywall/JC
- Green Cove Base and Mastic
- Split Face Masonry and Mortar
- Ceramic Tile and Thinset
- Plaster
- White Exterior Sealant

The building materials sampled were reported by laboratory PLM analysis to be “none detected” for asbestos.

Based on the previously referenced laboratory analytical data, there are no further recommendations at this time. If any un-sampled suspect building materials are discovered during the restoration activities, those building materials should be properly sampled by a certified inspector and analyzed by a qualified laboratory prior to their disturbance.
